Fort Knox Gold Mine

Summary

The Fort Knox Mine, a large gold mine in Interior Alaska, produces around 370,000 ounces of gold per year. This mine is a significant producer of mining waste in Alaska, but has had fewer environmental problems than many other large mines in the state.

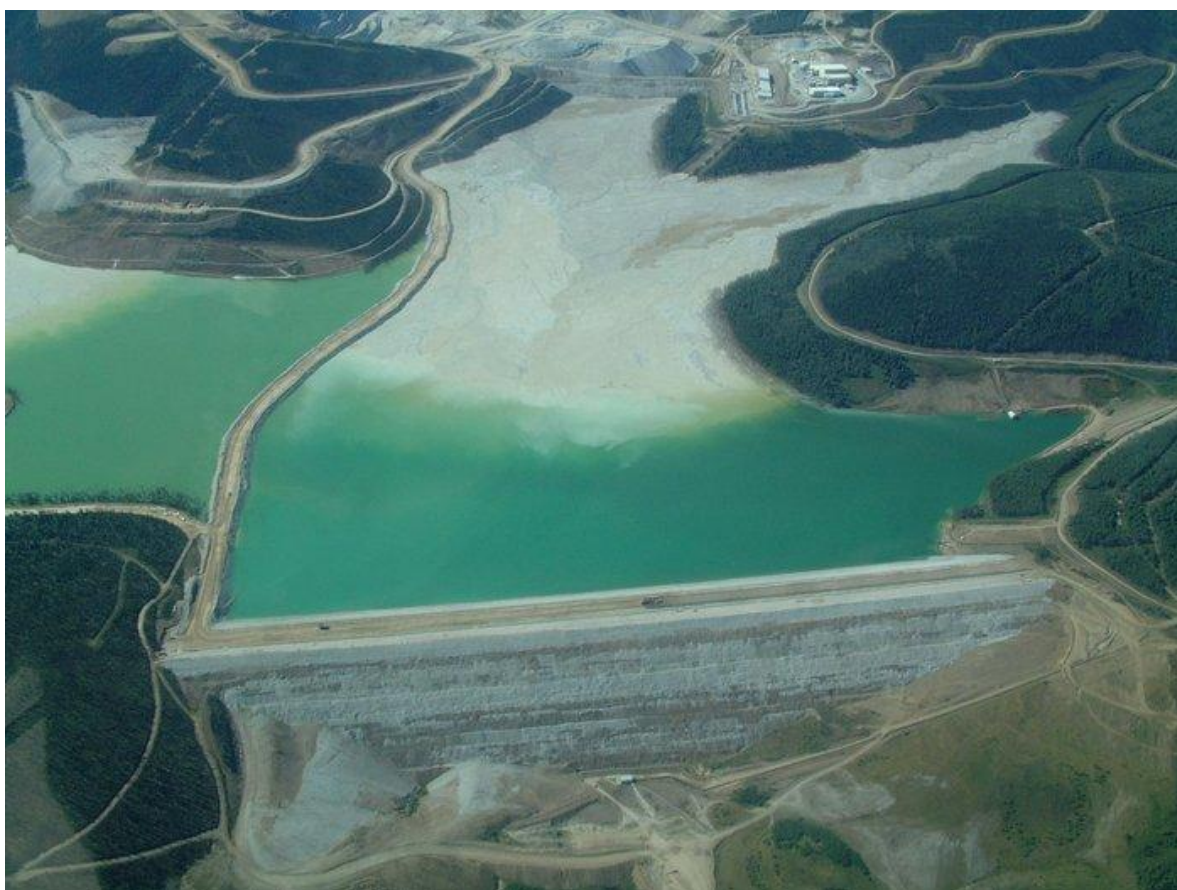
TAILINGS DAM AT FORT KNOX GOLD MINE — Mine tailings dam at [Fort Knox](/Issues/MetalsMining/FortKnoxMine.html) (</Issues/MetalsMining/FortKnoxMine.html>) gold mine with the mill facility in the background. — [Get Photo \(/photos/tailings-dam-at-fort-knox-gold-mine/\)](/photos/tailings-dam-at-fort-knox-gold-mine/)
